# Intel<sup>®</sup> Pentium<sup>®</sup> III Processor Specification Update

Release Date: October 2001

Order Number: 244453-034

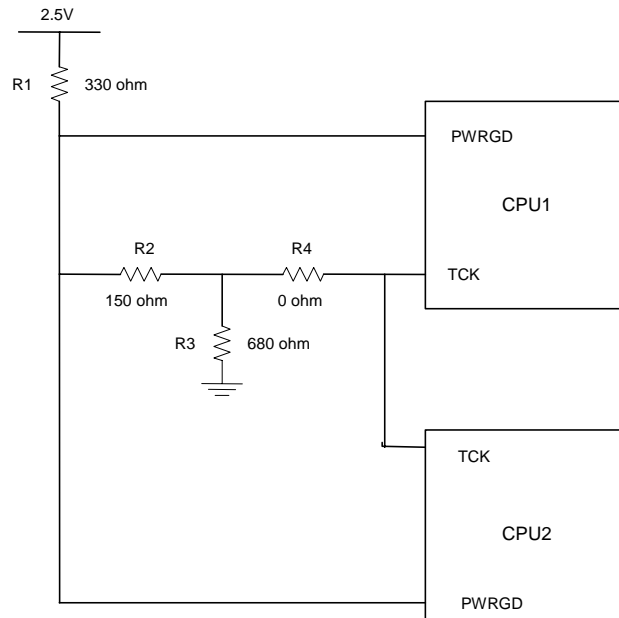
Pentium® III Processor with 512KB L2 Cache Platforms Workaround

In addition, the example workaround circuits shown do not support production **baseboard** test methodologies that require the use of the processor JTAG/TAP port. Alternative workaround solutions must be found if such test capability is required.

Assumes the inputs to the CPU\_PWRGD are open collector signals that are Wire-ANDed together

- The example workaround circuit assumes that the PWRGD inputs into the processors are open collector. Tying the PWRGD inputs together in a Wired-AND fashion allows each processor to receive PWRGD at the same time but at the latter of the 2 separate PWRGD assertions. If separation of the PWRGD inputs to each processor is required, extra circuitry will be required.
